Portland Harbor Superfund Site In-Situ Capping

Presentation to the
Portland Harbor Community Advisory Group
March 11, 2015
EPA Region 10

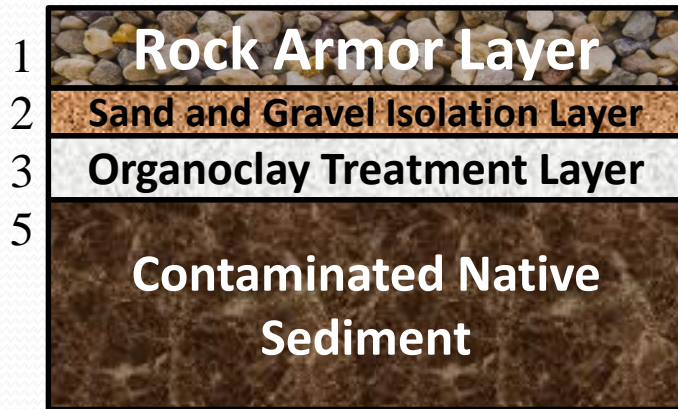
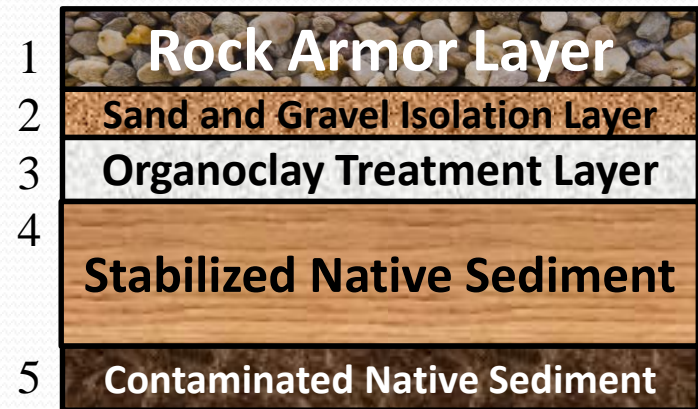
Examples of Caps

1. Rock layer to protect cap from erosion
2. Sand/gravel to isolate contaminated sediment
3. Treatment layer to contain or remove a specific contaminant
 - For example – oil absorption layer
4. Native soft sediment stabilized
 - For example – solidified with cement-like material
5. Contaminated sediment (untreated) under cap

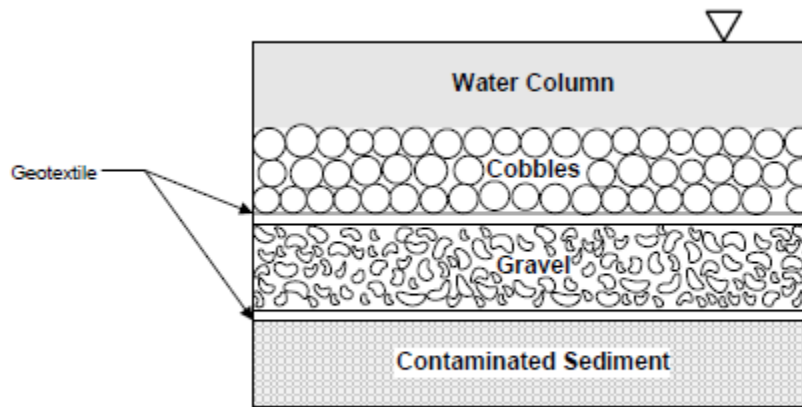
B. Sheboygan, WI

Geotextile: synthetic fabric to separate contaminated soil or sediment from the cap or to separate or protect different cap layers

Geogrid: rigid synthetic material used to reinforce sediment

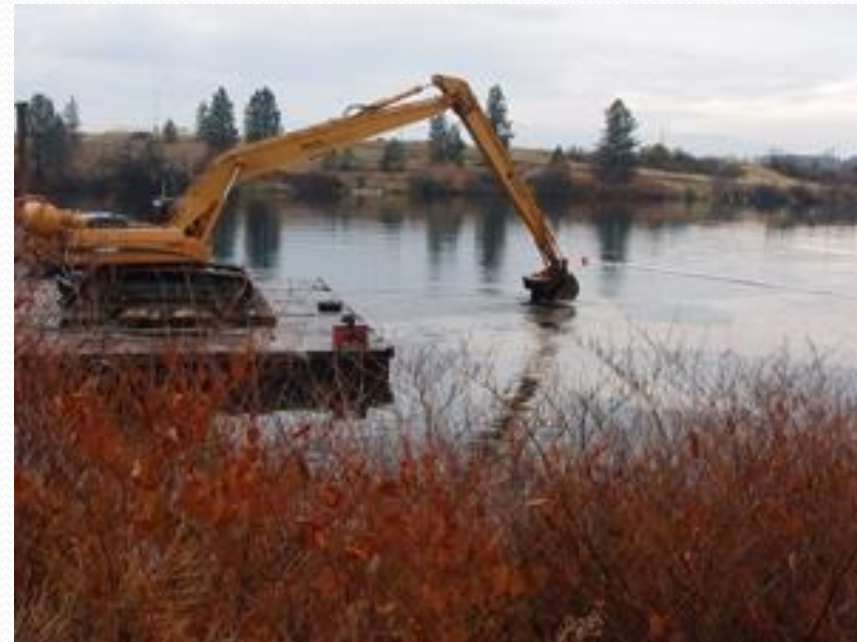
Cap Placement

- Spokane River Upriver Dam PCBs Sediment site (Spokane, Washington)
 - 3.5 acres
 - Sediment concentrations as high as 1,430 parts per billion
 - Washington State Department of Ecology issued a no fish consumption advisory
 - 2006 – amended cap applied

- 2008 – total PCBs below detection in sand and coal layers; cap is working

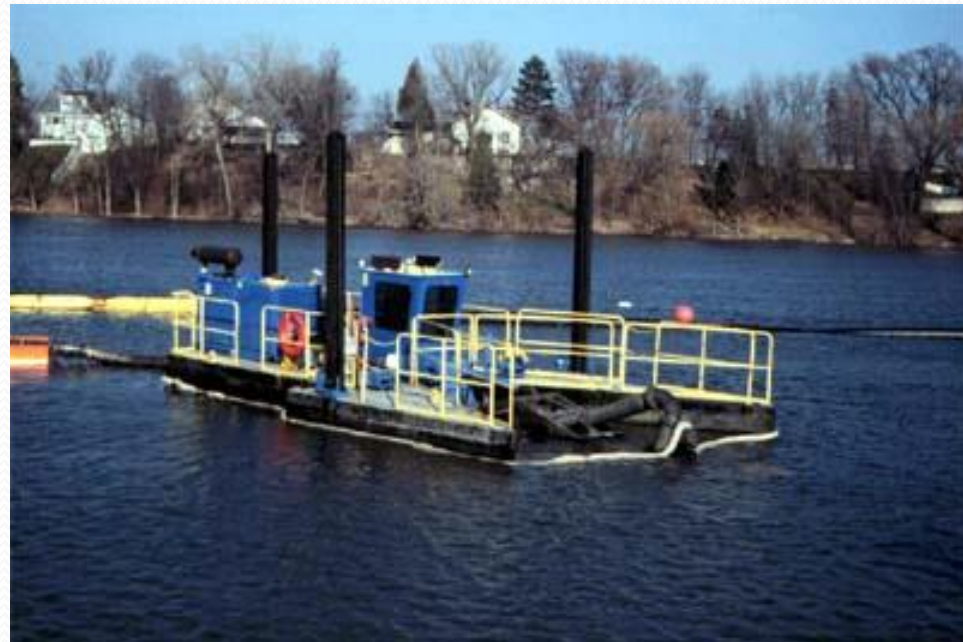
- Manistique River Area of Concern, next to Lake Michigan (Schoolcraft County, Michigan)
 - 15 acres (1.7-square-mile area of the Manistique River and Harbor)
 - 1996 to 2000 – EPA dredging
 - Capped with 40-mil (0.1-inch) plastic anchored by 38 two-ton concrete blocks around cap perimeter
 - Concrete blocks prevent erosion of contaminated sediments
 - 2001 – inspection confirmed cap was physically intact and most anchors in place.
 - 2001 – 10-ppm PCB concentration goal met
 - 2004 – 1 ppm PCBs remaining in river and harbor sediments

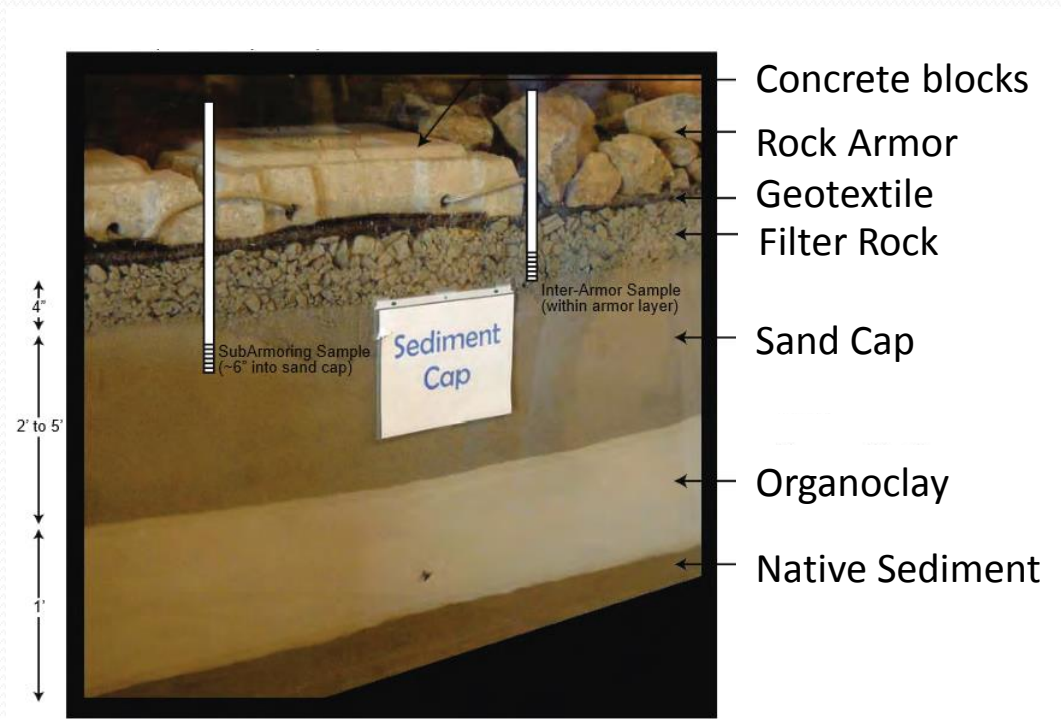
Typical Sediment Cap Section

- McCormick & Baxter site (Willamette River, Portland, Oregon)
- 23-acre area
 - Sediment contaminated with PAHs, creosote, diesel, pentachlorophenol and heavy metals
 - Risk from direct contact with sediments
 - 2005 – amended cap applied
 - 2010 – PAHs in cap below National Recommended Water Quality Criteria, with exception of chrysene in one sample
